TECHNICAL REPORT REMR-CO-3

**CASE HISTORIES OF CORPS BREAKWATER
AND JETTY STRUCTURES**

Report 9

SOUTHWESTERN DIVISION

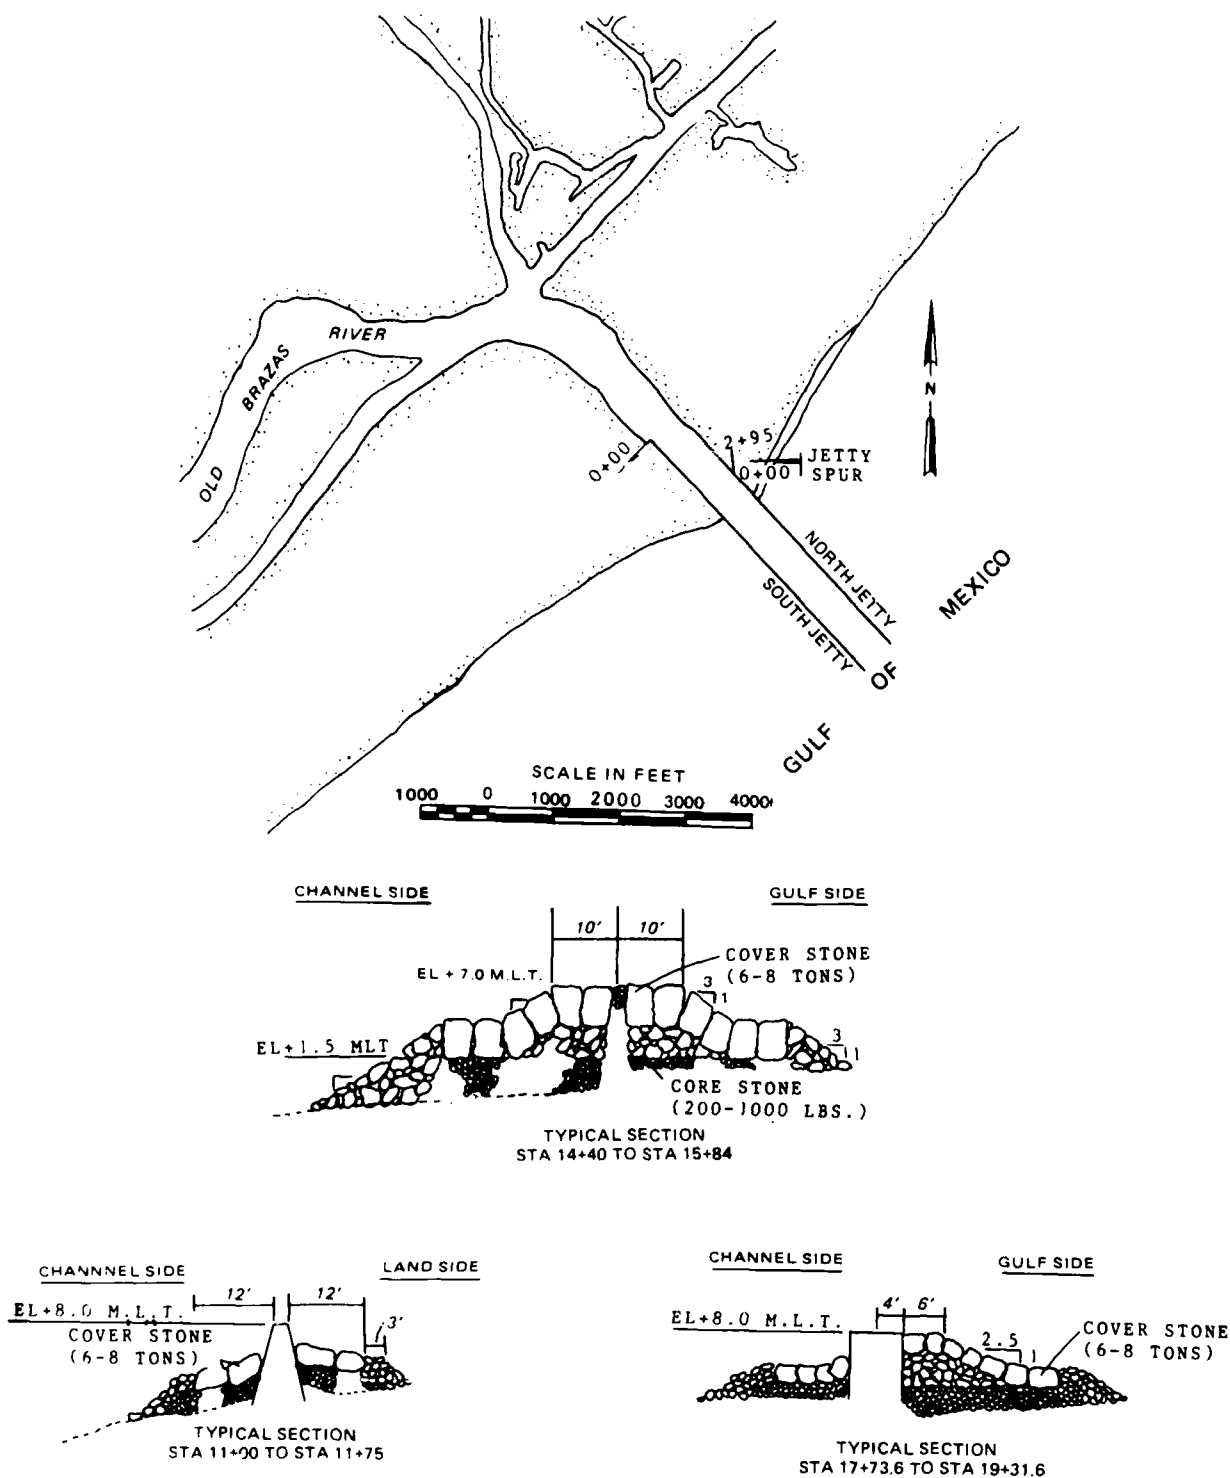
Figure 5. Plan view of Freeport Harbor jetties and typical south jetty repair sections

1968	Two sections of the south jetty, from sta 11+00 to sta 11+75 and sta 17+70 to sta 19+30, were repaired by buttressing the concrete cap with stone and placing concrete between sta 18+00 and sta 19+05 (Figure 5). The landward section was subjected to undermining and piping beneath the cap. The cap on the outer section had collapsed, due to undermining, with about 20 ft at +1 ft mlt and the remainder between +1 and +8 ft mlt. The concrete was placed to the original dimensions of +8 ft mlt and an 8-ft width. Stone was placed on the gulf side of the cap to +8 ft mlt, a 6-ft top width and 1V:2.5H side

1986	Except for the more recent repair sections, the jetties are in poor condition, with many voids under the concrete caps and numerous cracks in the caps themselves. Jetty rehabilitation has been delayed pending authorized project improvements which include relocating the north jetty and channel deepening.

Date(s)	Construction and Rehabilitation History
1968 (cont.)	slope. The remaining repairs consisted of buttressing the cap with 12-ft-wide bedding and cover stone layers. A 3-ft-wide layer of toe protection was placed along the outer edge of the repair sections. Stone sizes were 6 to 8 tons for the cover layer, 200 to 1,000 lb for the core (placed on seaside of outer section only) and toe protection, and 0.5 in. to 200 lb for the approximately 3-ft-thick bedding layer. Cost totaled \$65,300 using 4,410 tons of stone.
1977	Minor repairs were made at a total cost of \$9,200. (No details are available.)
1984	Two sections of the south jetty were repaired (Figure 5), and a 295-ft-long rubble-mound spur was placed at sta 8+40 on the north jetty's landward side. The south jetty repairs, from sta 14+40 to sta 15+85 and sta 19+20 to sta 20+20, consisted of a +7 ft mlt crown elevation, a composite width (including the cap width) of 20 ft and 1V:3H side slopes. A bedding layer of 0.5-in. to 200-lb stone was placed to +1.5 ft mlt and extended 26.5 ft from the jetty center line. Stone sizes were 6 to 8 tons for the cover layer and 200 to 1,000 lb for the core and toe protection. The toe protection was placed on a 1V:3H slope along the outer edge of the cover and bedding layers. The spur projected landward from the north jetty at a 30-deg angle and was built to an elevation of +6 ft mlt, a 5-ft top width, and 1V:1.5H side slopes. One-half inch to 200-lb blanket stone were used, except for a 90-ft section adjacent to the jetty. Single 4- to 6-ton stones were placed along the crown. The purpose of the spur was to minimize sand movement over the lower (+4 ft mlt) landward jetty section that was building a channel side shoal with the potential for future channel encroachment which would require subsequent maintenance dredging.

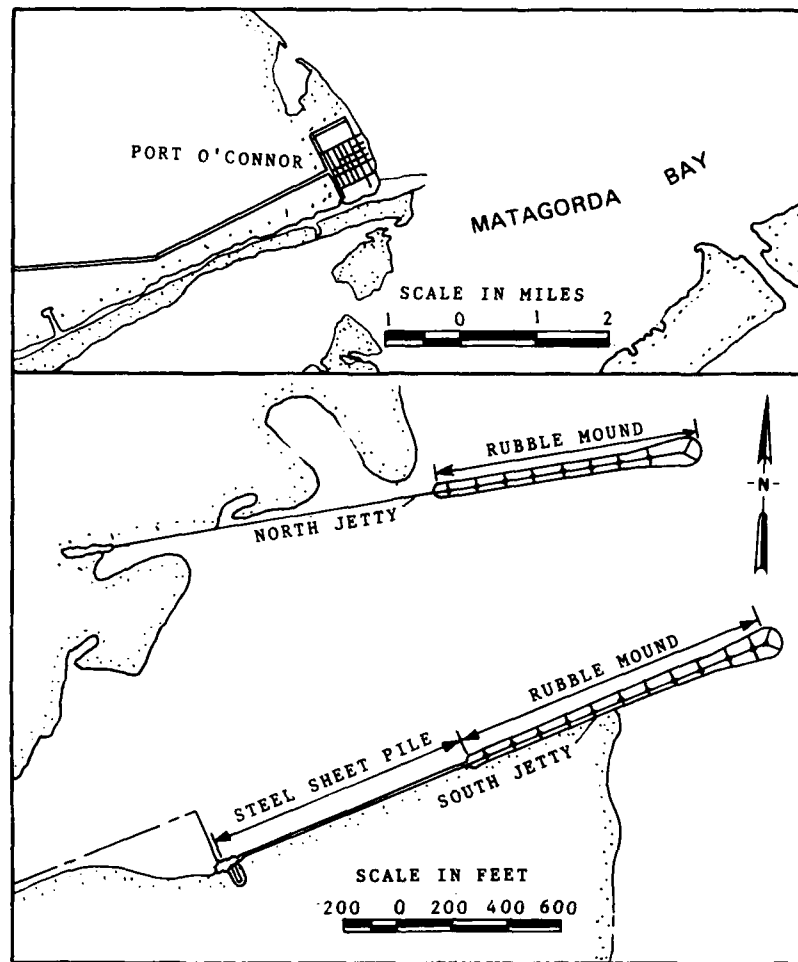
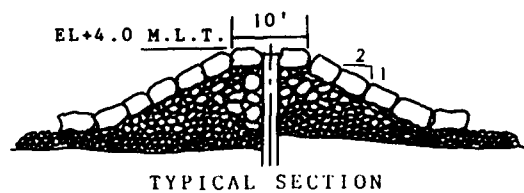
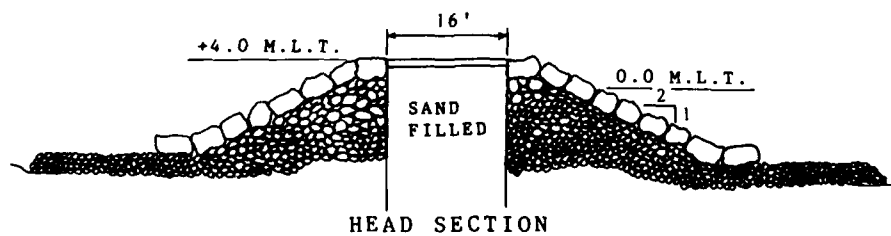
Figure 9. Location, plan view, and typical sections of Port O'Connor jetties

Date(s)	Construction and Rehabilitation History
1964- 1965 (cont.)	time of the repairs the jetties were in fair condition (mostly general corrosion), except at their outer ends where scour and active soil pressures were evident, and the shoreline was eroding at the landward ends. The cover stone size was determined from Hudson's slope stability formula and a maximum depth-limited wave height of 12 ft. Existing elevations along the jetties varied from +2 to -11 (seaward ends) ft mlt. The rehabilitation cost was \$397,800 and required 46,910 tons of stone.
1971	Riprap stone (0.5 in. to 200 lb) was placed on the north jetty landward end. The shoreline had eroded leaving a gap of approximately 50 ft. A total of 600 tons of stone was placed at a cost of about \$9,000.
1984	Except for general deterioration (corrosion) at several locations of the exposed sheetpiling, the jetties were considered to be in good condition (visual inspection). The present overall lengths of the north and south dikes are 2,300 and 2,250 ft, respectively.

1964- 1965	<p>The jetties were rehabilitated by placing a rubble-mound cross section (Figure 9) along the outer 800- and 1,200-ft sections of the north and south jetties, respectively. In addition, scour protection was added to the remainder of the south jetty channel side, and shore protection was added at the landward ends of the dikes. The rubble-mound sections, with the existing jetties at the center line, were placed to an elevation of +4 ft mlt; side slopes were 1V:2H, and the crown width was approximately 10 ft (two cover stones wide, one on either side of the sheetpiling). The section was built up on a 2-ft-thick bedding layer (3 ft at seaward end) of 0.5-in. to 200-lb stone, a core of 200- to 1,000-lb stone, and a single layer of 2- to 4-ton cover stone. Filler stone (0.5 to 4 in.) also was placed with the core stone (a section 3 ft wide on either side of the sheetpiling and extending downward at 1V:1H side slopes). The bedding layer extended from 5 ft (landward) to 15 ft (seaward) beyond the toe of the cover stone layer. The landward 700 ft of south jetty bay side rubble mound consisted of a 2-ft-thick bedding layer placed between 0 and +2 ft mlt followed by a 2-stone-wide cover layer (+4.5 ft mlt crest elevation). South jetty scour protection was placed on 950 ft of the channel side (landward of the rubble-mound section) and consisted of a 2-ft-thick by 10-ft-wide layer of 0.5-in. to 200-lb stone. The north jetty was extended 50 ft landward, and a 30-ft-long perpendicular spur was added at the landward end (bay side) of the south jetty. This shore protection used 0.5-in. to 200-lb stone placed between 0 and +4 ft mlt with a 4-ft crown width and 1V:2H side slopes. At the</p>

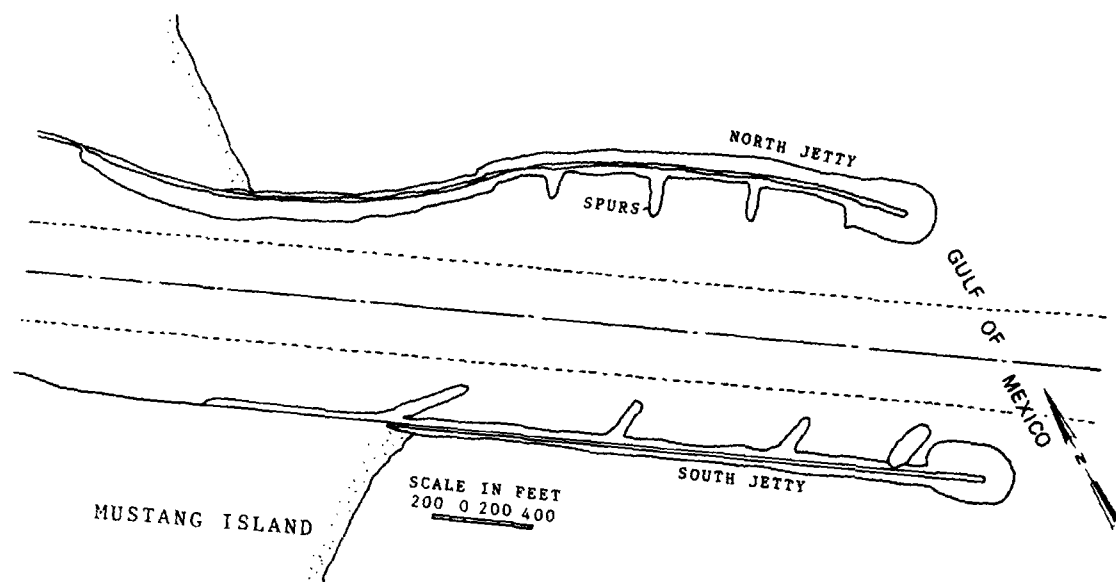
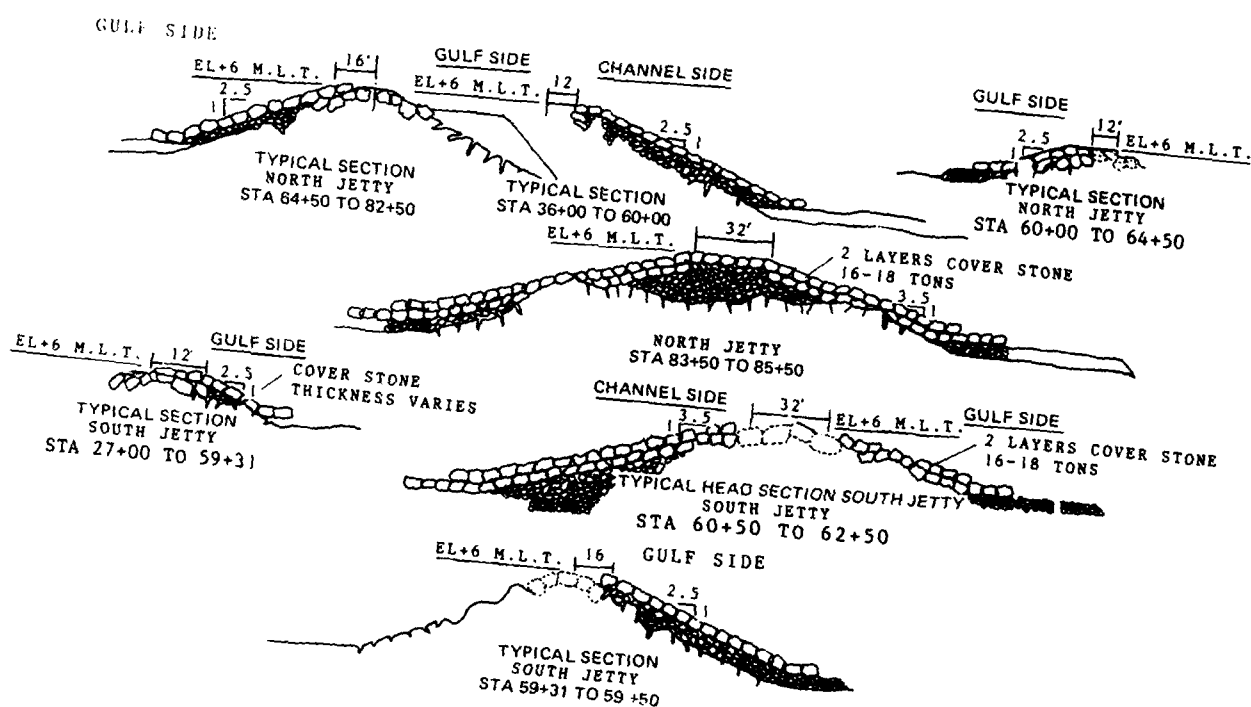
Figure 11. Aransas Pass jetties, plan view and typical cross sections

1967	<p>Hurricane Beulah's passage in October displaced cover stone at several locations, with an estimated 100 pieces missing or displaced from each jetty. Near the landward ends of the jetties sand was washing or piping under the concrete caps and into the ship channel. It is not known whether this piping was due to the storm or if it had been a previous problem. These sections were located from sta 12+00 to sta 24+00 on the north jetty and from sta 10+00 to sta 25+00 on the south jetty (landward ends at sta 0+00).</p>

Date(s)	Construction and Rehabilitation History
1970	The jetties were inspected after the August passage of Hurricane Celia. Displaced cover stone was noted at the seaward end of the north jetty (the convex portion of the north jetty's channel side) and a section of the south jetty's gulf side adjacent to and seaward of the existing shoreline. It was not known how much of the existing damage was caused by Hurricane Celia since no repairs were made subsequent to Hurricane Beulah.
1972	The jetties were repaired by adding and resetting cover stone on damaged sections noted during the 1970 inspection (see above). Repair areas on the north jetty channel side included 10 sections totaling 1,010 lin ft between sta 35+50 and sta 64+00, where 10- to 12-ton stone was added and the displaced 4- to 10-ton stone reset. At the north jetty seaward end displaced 16- to 18-ton stone were reset along 300 ft of channel and head semicircle side slopes. The south jetty's gulf side between sta 27+00 (existing shoreline) and sta 29+30 was repaired by adding 4- to 6-ton stone, and its channel side was repaired between sta 16+50 and sta 20+50 by adding 1,000- to 4,000-lb riprap stone. Total cost of the repairs was \$129,500.

1978	Seven sections of the south jetty totaling 980 lin ft between sta 8+70 and sta 24+50 were repaired by placing stone on the landward side of the concrete cap. Scour beneath the cap had caused piping and removal of sand along its landward face. Although this condition had existed for several years, repairs were considered necessary due to the size of the scour holes and concern for human safety. The repairs consisted of placing a 1.5-ft-thick bedding layer of 0.5- to 6-in. stone extending 12 ft from the cap and covered with a 2.5-ft thickness (but not to project above the cap) of 200- to 1,000-lb riprap extending 8 ft from the cap. Total cost of the repairs was \$60,700.
1984	The jetties were inspected and considered to be in good condition with the exception of 10 to 20 cover stones that were displaced along the channel side of each jetty's head section, displaced cover stone along the north jetty channel side, and settlement of some supporting stone beneath the concrete caps.

Date(s)	Construction and Rehabilitation History
1908- 1917	The north or Haupt jetty was repaired and extended 3,490 ft landward which closed the gap, and a 7,385-ft-long south jetty was constructed (Figure 11). The jetties were roughly parallel, spaced 1,500 ft apart, with the south jetty extending 1,150 ft seaward of the north jetty. The jetties were built up to +5 ft mlt and crest widths of 10 to 20 ft using small riprap (15 to 200 lb), large riprap weighing 200 lb to 7 ton, and crest stone greater than 7 tons comprised 7 percent of total. The total quantity of stone placed on the north and south jetties was 162,400 and 253,900 tons, respectively. These totals include minor repairs made during 1916-1917. The total cost for jetty improvements during this period was \$1,544,500. In 1911, portions of the Mansfield and Nelson jetties were removed from the channel at a cost of \$14,300. The authorized 20-ft channel depths were obtained during construction as the tidal flow and resulting bottom scour were gradually confined.

Date(s)	Construction and Rehabilitation History
1964- 1966	<p>The jetties underwent major rehabilitation using the recommendations and design proposed in 1962 (Figure 11). The new seaward ends of the 4,950- and 3,550-ft-long repair sections terminated 790 and 1,135 ft from the original seaward ends of the north and south jetties, respectively. The south jetty repairs consisted of a rebuilt gulf side slope, a 200-ft-long head section, and a 250-ft channel side spur located 550 ft landward of the head. The north jetty repair section had the landward 2,410-ft channel side and adjacent (seaward) 2,250-ft gulf side slopes rebuilt. The final 300 ft were rebuilt as a transition and 200-ft head section. The head sections had a crown elevation of +6 ft mlt, a 32-ft crown width and 1V:3.5H side slopes. The 16- to 18-ton cover stone was placed as a double layer on the side slopes and single layer on the crown. The 200- to 4,000-lb core stone was partially supplemented with 0.5- to 4-in. filler stone (in a section extending beneath the crown at 1V:1H side slopes) for the purpose of decreasing structure permeability. The 0.5-in. to 200-lb blanket stone was placed in a 5-ft-thick layer and extended 50 ft beyond the toe of the cover layer. The jetty trunk sections were rebuilt to +6 ft mlt and a 1V:2.5H side slope. The crown extended two cover stones in width from the existing 12-ft-wide concrete cap sections or 14 ft from the center line of the north jetty grouted cap (1,800-ft section). The single layer of cover stone varied from a minimum of 2 to 4 tons at the south jetty landward end to a maximum of 16 to 18 tons at the jetty seaward ends. The blanket layer was placed in 3-, 4-, or 5-ft thicknesses and extended 10 ft beyond the toe of the cover layer. Prior to placing the core stone the existing void spaces were chinked with filler stone. The filler, blanket, and core stone size ranges were the same throughout the repair sections (see above). The south jetty groin consisted of core stone placed to -18 ft mlt, a 10-ft crown width, and 1V:1.5H side slopes. The core stone was placed on a 5-ft layer of blanket stone which extended 10 ft beyond the toe of the core stone. The total cost of rehabilitation was \$3,367,000 and required 410,250 tons of stone. The jetty design was based on Hudson's slope stability formula, depth- and fetch-limited wave heights, and a maximum storm surge level of +13 ft mlt. The 18-ton maximum cover stone was inadequate for maximum design conditions but was selected for practical and economic reasons.</p>

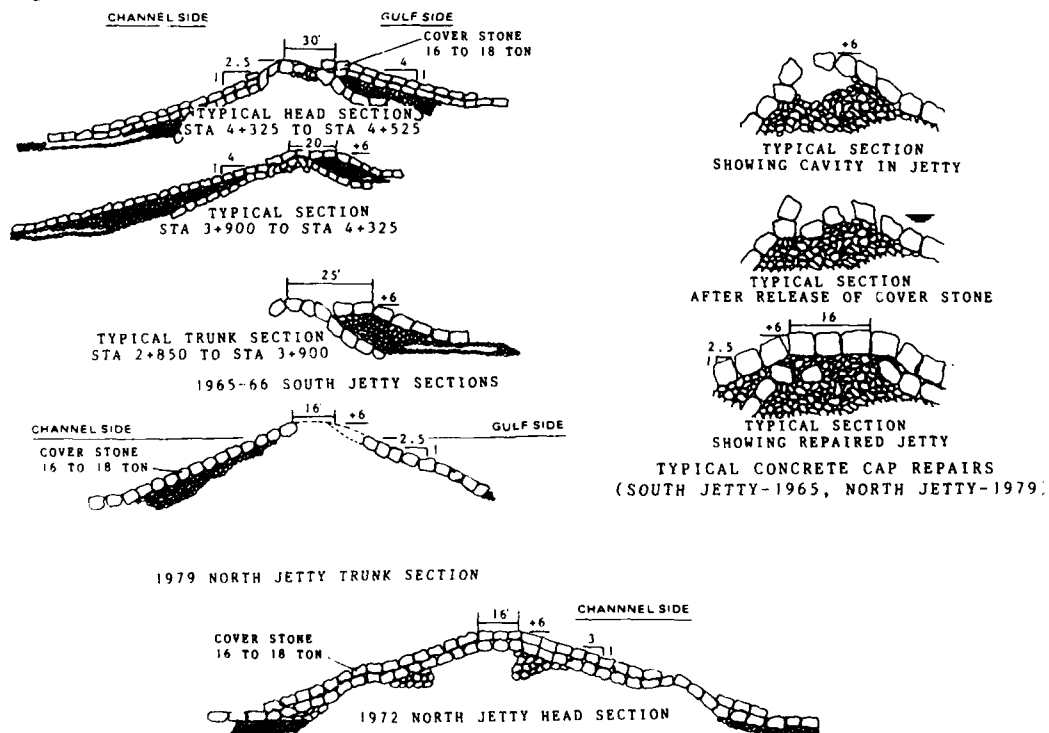
Figure 15. Typical repair sections of the Brazos Island jetties

Date(s)	Construction and Rehabilitation History
	<p>breaking up the concrete cap at sections where underlying cavities had formed. The released cover stone was left in place and overlaid with new cover stone bringing the sections up to the +6 ft mlt design elevation. The north jetty repair, located approximately 3,500 ft from the seaward end, brought the channel side up to grade by placing blanket stone, resetting existing cover stone, and adding new 200- to 1,000-lb core stone and 2- to 4-ton cover stone. The 3-ft-thick blanket of 0.5-in. to 200-lb stone extended 10 ft beyond the toe of the cover layer. The section was brought up to +6 ft mlt and a side slope of 1V:2.5H. Water depths were -35 ft mlt along the seaward end of the north jetty toe and from -20 to -40 ft mlt along the seaward end of the south jetty toe. The authorized 38- by 300-ft channel has been maintained since 1957. Hudson's slope stability formula was used in the design with 10- to 35-ft wave heights. The design storm surge was +13 ft mlt. The stone sizes used were smaller than required to satisfy a no-damage criterion, with slope stability coefficients varying from 2.5 to 12.5 but being used for practical and economic reasons. The total cost of the repairs was \$584,000 using a total of 60,600 tons of stone.</p>

1967	<p>During September 1967, storm waves from Hurricane Beulah damaged the landward 1,130 ft of the 1965-1966 south jetty repairs. About 90 percent of this section of gulf side slope repairs had varying degrees of displaced stone. The damage appeared to be due to the placement of the stone against the concrete cap (a smooth impermeable section allowing very little natural interlocking of the cover layer combined with possible adverse changes in the magnitude and direction of wave forces). In 1968 this section and a portion of the jetty's channel side slope were repaired. On the gulf side, the concrete cap edge was broken off providing a buttress for the cover layer which was rebuilt by resetting existing cover stone and adding new filler, core, and cover stone. Also repaired were sections where undermining and cavities had formed beneath the concrete cap. In these areas the cap was broken up and overlaid with core and cover stone as was done for the 1965-1966 repairs. A 700-ft section of the south jetty (located approximately 3,700 ft from its seaward end) was repaired along its channel side by rearranging the existing cover stone and adding new filler, core, and cover stone. The south jetty repairs employed 0.5-to 4-in. filler stone, 200- to 1,000-lb core stone, and 6- to 8-ton cover stone. The north jetty shore protection was repaired by placing a 2-ft-thick bedding layer of 0.5-in. to 200-lb stone, 15-ft-wide cover layer of 6- to 8-ton stone, and 200- to 2,000-lb toe protection stone. The existing stone had moved up the shore slope during large storm events. Approximately 550 lin ft of shore protection were placed landward of the jetty. The total cost of the repairs was \$274,000 using 14,100 tons of stone.</p>

1977- 1979	<p>By the end of 1977, sections of the north jetty concrete cap had collapsed, other sections were cracking, and its seaward end needed repair. All of the noted areas of cap damage were located along the channel side. The damaged areas were similar to those seen previously on the south jetty cap where undermining and settlement of the underlying stone had created cavities beneath the cap. It was thought that Hurricane Anita in August 1977 was the force which triggered most of the cover stone breakage and collapse, because the jetty was considered to be in good condition during a June 1977 inspection. The north jetty channel shoreline was continuing to erode. Since 1962, the shoreline had receded about 200 ft, a rate of 13 ft per year. The channel end of the 1971 shoreline protection was now offshore. (The 1961 shore protection stone was virtually non-existent.) During 1978-1979, repairs were made to the north jetty and adjacent shore protection. The seaward 35 ft and 1,700 ft of the jetty trunk were brought up to grade using 16- to 18-ton cover stone, 100- to 4,000-lb core stone (2,000-lb maximum on landward 1,000 ft of trunk), and 0.5-in. to 200-lb blanket stone. The trunk section (Figure 15), starting 500 ft from the seaward end and extending landward, had a 16-ft crown width, a +6 ft mlt crown elevation, and 1V:2.5H side slopes. The concrete cap was broken up, and the released cover stone projecting above +1 ft mlt was removed and used as cover stone in the shore protection (Figure 15). New core and a single layer of cover stone then were placed to obtain the required design geometry. A 3-ft-thick bedding layer was placed from</p>

Date(s)	Construction and Rehabilitation History
1977- 1979 (cont.)	the base of the existing jetty and extended 10 ft beyond the end of the new cover layer. The seaward end repair was identical to the 1971-1972 work, except that 1V:3H side slopes were used throughout. Displaced cover stone was reset on the adjacent 100 ft of jetty. The north jetty shore protection was extended 1,470 ft along the channel shoreline; this included 150 ft of the existing shore protection which was salvaged and rebuilt, and repairs were made to the existing section. The design was nearly identical to that used in 1968 on the existing shore protection. (Toe protection was 200 to 1,000 lb and placed with a top width of 5 ft.) The jetty design was based on Hudson's equation with a maximum wave height of 26.5 ft (trunk) and a maximum surge level of +10 ft mlt. Similar to previous improvements, the selected jetty design was chosen for economic and practical considerations in lieu of a "no damage" design. Total cost of the jetty repairs and shore protection was \$5,905,000 using approximately 140,000 tons of stone.
